MARINE SURVEYS LTD

GENERAL CONDITION SURVEY REPORT

For Yacht IMX 40 'Cracker'

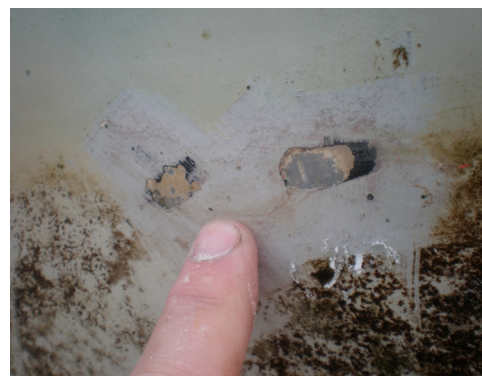
FIG 1

The vessels bottom was cleaned of weed, crustaceans and other marine growth, and the antifouling coating was found generally in a good condition, with the remaining adhering well to the shell suggesting compatible paints had been used. Where considered necessary in the circumstances at the time of the survey, paint coatings were removed from the shell (in sample areas only) in order to evaluate the local gel coat condition in those areas. This was done to allow the

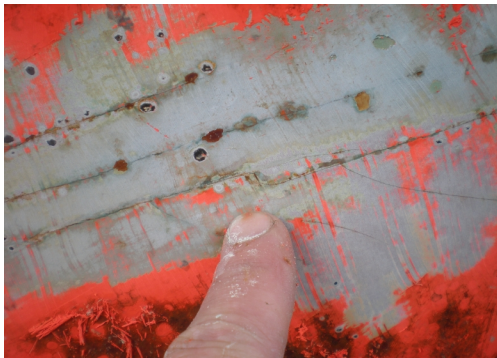
FIG 2

Note: Such cracks are often caused in these areas by limited structure of the gel coat, but do not effect the structural integrity of the adjacent solid structure. No indications of serious degrading were noted.

1. Employ a competent boat builder to repair the fine cracks observed in the gelcoat around the head of the keel and around the lower ballasted areas on both sides (see Fig 2 and Fig 3). These fine cracks were of no structural consequence, but it is advisable to have them ground out, dried, sealed and rectified as soon as possible. (Morgan Marine quoted £1500 Sterling for repairs on the day of my Inspection, this will include the craning out of the vessel).

1. Employ a competent boat builder to repair the fine cracks observed in the gelcoat around the head of the keel and around the lower ballasted sections on both the port and starboard sides (see page 5, Fig 2 and Fig 3). These fine cracks were of no structural consequence, but it is advisable to have them ground out, dried, sealed and rectified as soon as possible. (Morgan Marine quoted £1500 Sterling for repairs on the day of my Inspection, this will include the craning out of the vessel).

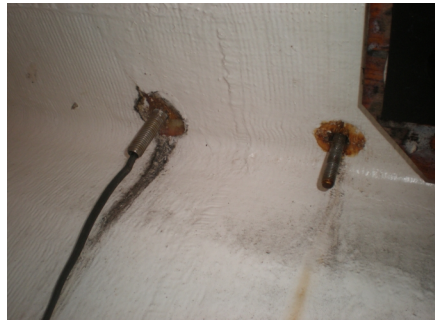
FIG 4

The safety rail around the anchor platform was slightly bent and the nuts which secure the rail on the starboard side were missing. The mooring cleat on the port aft quarter requires removing sealing and refitting (rain water ingress observed).

1. Secure the safety rail around the anchor platform. (2 x nuts missing/ access via chain locker/ see Fig 4).
2. The mooring cleat on the port aft quarter requires removing sealing and refitting (rain water ingress observed through steering gear compartment).

2. Secure the steel safety rail around the anchor platform. (2 x nuts missing/ access via chain locker/ see page 7, Fig 4).
3. The mooring cleat on the port aft quarter requires removing sealing and refitting (rain water ingress observed through steering gear compartment).

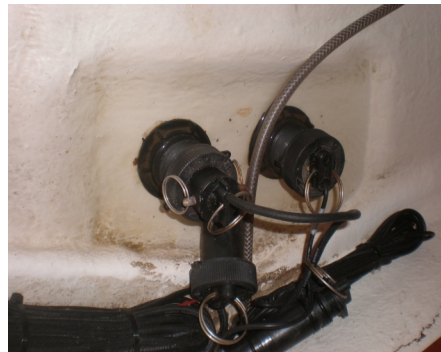
Note: The water around the transducer fittings below the forward berth (see image above) has sourced from the leaking hand rail around the anchor platform. As mentioned previously.

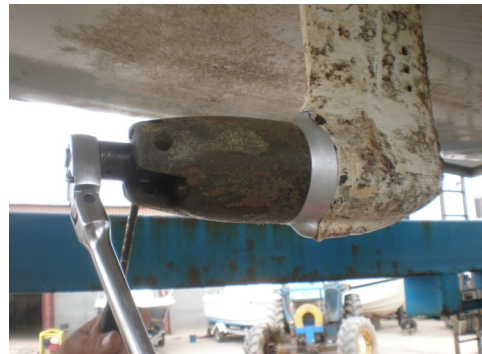
The stern gear was examined externally-without opening up-and was found in a good serviceable condition overall. The propeller showed no sign of corrosion and the propeller blades were individually sighted for obvious signs of deformation, with none found. The propeller was removed during my inspection by an Engineer employed by Morgan Marine, and the sacrificial anode replaced, it was refitted and was a snug fit to its shaft and was properly secured. When the shaft was rotated by hand it was free. (see image).

The sail drive seal was secure and in a good condition with no obvious signs of water ingress in way of the seals or glands noted. The drive was secure with no sign of corrosion or dezincification in the metal.
