MARINE SURVEYS LTD

GENERAL CONDITION SURVEY REPORT

For Yacht IMX 40 'Cracker'

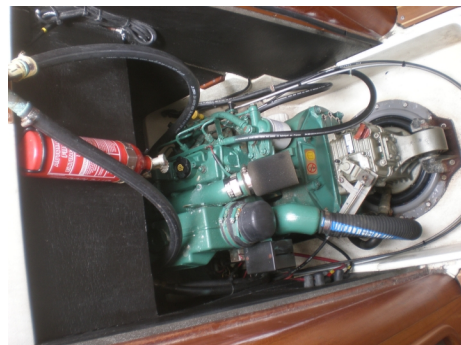
A visual inspection of the engine, filters and related connections showed no signs of abuse and a good maintenance regime became apparent. The stringers that support the engine mounts were cored fibre glass and in turn they were secured to the hull and appeared to be free of stress. The main flexible engine mountings were in good order. The crankcase oil was checked and appeared to be clean and at the correct level.

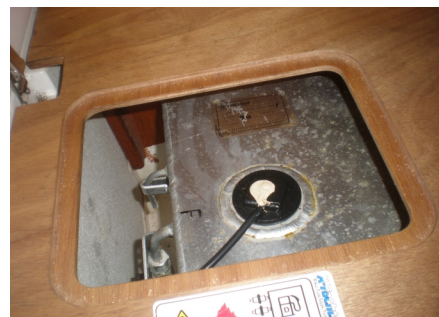
The vessel was fitted with one free standing fuel oil tank of alloy construction which was examined as far as practical (but not pressure tested) and found externally in a good condition. The tank was not filled up and it was not possible to check fully its oil tight integrity and this is not guaranteed. There was however no 'obvious' signs of leakage from any of the joints or fittings. The tank appeared

to be properly secured and no sign of movement was observed. The vent pipe was properly protected with a single flame arrestor. The tanks filling pipe was not completely accessible, however the filling hose appeared to be taken into the cockpit and was so arranged that it was not possible for fuel to overflow into the vessels hull or bilge. The fuel was drawn from the top of the tank, with the correct stop cock installed.

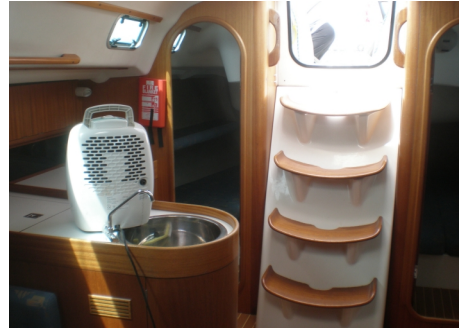
The interior was found to be in a good cosmetic condition overall considering the use the vessel, racing etc. The saloon, and berths were fully lined and fitted out to a good standard. Soft furnishings remain in fair order. It is not known whether the foam used in the soft furnishings was fire retardant. Bulkheads and joinery work were in good order, and the majority of the drawers and locker doors appeared functional.

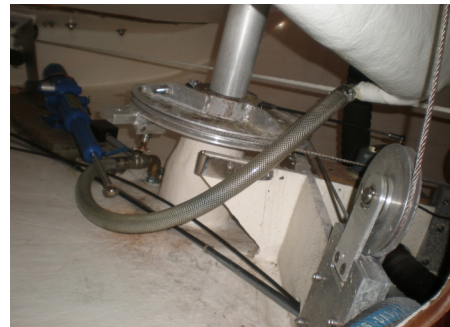
The vessel was fitted with a mechanical type steering system with a large spoked wheel fitted at the helm. This was tried hard over to hard over (3 full turns of the wheel) and found in good, smooth operational condition and to sit correctly on the stops. The drag links, cables, pullies and quadrant were examined and found secure and in good order. It was not possible to test the steering under any load as the vessel was ashore at the time of the inspection.

The rudder was constructed from fibreglass. The rudder was showing no signs of damage or cracking. The hangings were found good without undue wear.

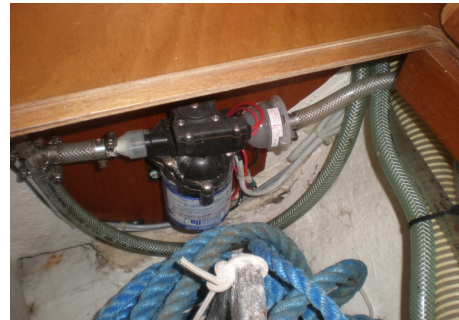
The vessel was fitted with a freshwater tank of free standing steel construction which was examined as far as practical and found externally in generally good condition. The tank was not filled up and it was not possible to check fully its watertight integrity and this is not guaranteed although no signs of leakage from the joints or fittings were noted. It was not possible to open up the tank and inspect its interior. The quality of the water inside was not tested.

The plumbing was of the plastic flexible piping fitted with a pressure pump and was examined as far as practicable and found generally in good order with the worm drive clamps in a good condition. There was a small leak noted on the freshwater pump.

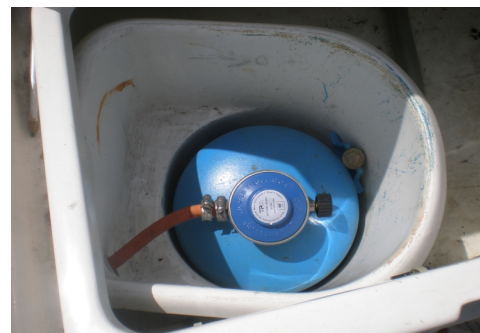
A two burner gimbaled stove was securely mounted in the galley. A satisfactory flame picture was present at each LPG appliance burner when all burners in the system were operating at their maximum setting at the same time.

The system was powered by liquid petroleum gas. The gas was supplied from one small cylinder situated in a vented GRP gas locker located in the cockpit. The locker was adequately vented overboard. The locker was examined all over and found to be in a good condition, and dedicated for its use. There was good access to the main shut off valve.

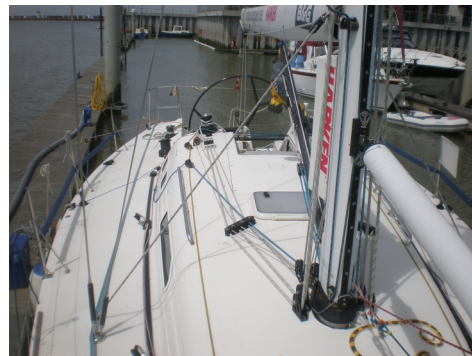
A main mast, and boom with tabernacle support were examined up to head height only, and no damage or deterioration was visible to the accessible part of these spars.

Standing rigging was of steel rod and examined up to head height and found to be in a good condition overall, with no signs of corrosion or dezincification in the metal. The running rigging was inspected and found adequate and in a good condition.
